ARMED SERVICES BOARD OF CONTRACT APPEALS

Appeal of -)
)
Hamp's Construction LLC) ASBCA No. 62257
)
Under Contract No. W912P8-12-C-0047)

OPINION BY ADMINISTRATIVE JUDGE PROUTY

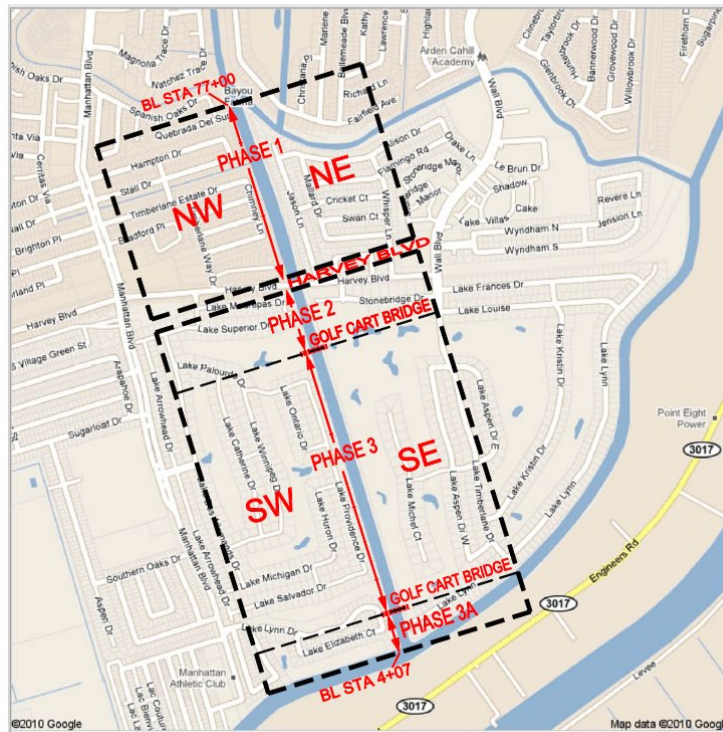
1. BASE WITH ORIENTATION

sector; a northwest sector; a southeast sector; and a southwest sector. The northern sectors are about half as long as the southern ones. Two small wooden bridges, for use by golf carts, cross the Trapp Canal south of Harvey Boulevard (tr. 1/31).

Access to the banks of the canal for construction was to be obtained at the location of the Harvey Boulevard crossing and the plan was for the work to begin on the northern sectors and, once those were completed, to move to the sectors south of Harvey Boulevard.¹⁰
